Colorado School  
for the Deaf and the Blind

# TEN-YEAR FACILITY MASTER PLAN REPORT

COLORADO SCHOOL FOR THE DEAF AND THE BLIND

#823291-01 | 06.24.2025 ADD02

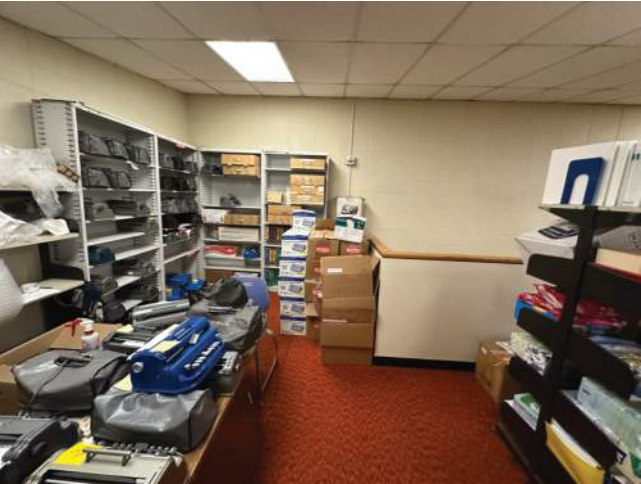
The most pressing spatial needs for the Blind school relate to storage. The equipment that is required by VI students is substantially larger than that for mainstream students. The classrooms in Adams do not have adequate space for the readers and Braille books needed. Additionally, the numbers of students with additional disabilities are continually increasing, requiring more space for walkers, wheelchairs, standers, and additional paraprofessionals in the classrooms to support these students. Other needs mentioned frequently are accessible restrooms, more sinks for hand washing, better acoustics, and lighting.

Storage conditions in Adams Hall

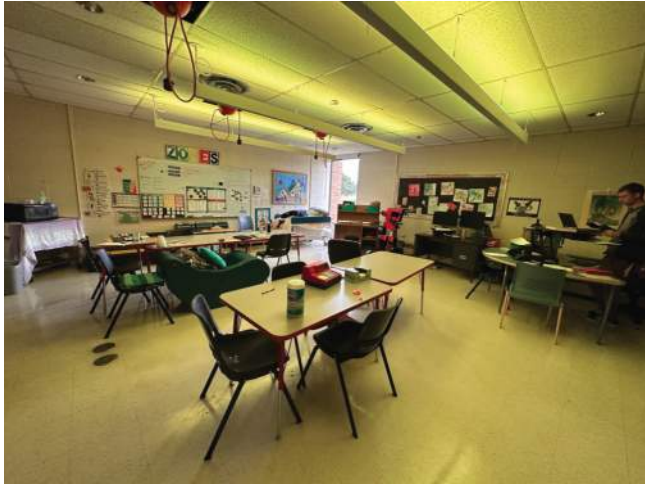
Additional disabilities classroom with bed, stander, readers and desks

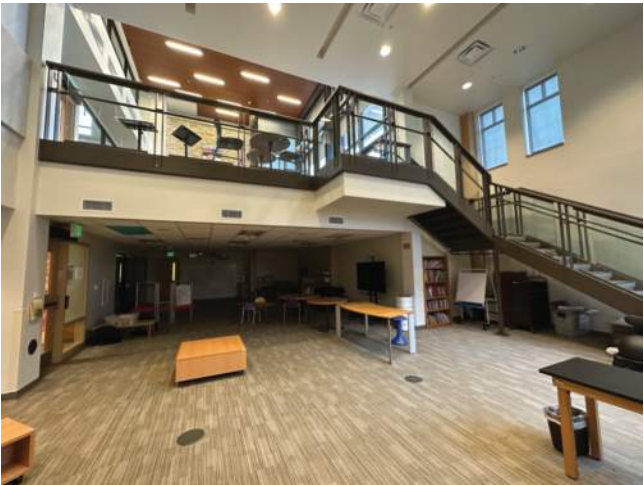
Spatial needs in Gottlieb are centered around inefficient use of spaces, lack of office space, and security concerns. With the relocation of the library to Lions Hall, the two-level Media Center is under utilized and difficult to use effectively. Additional office space is needed for the number of specialists, including psychologists, speech pathologists, and counselors. The security concerns are due to the extent of glass at the main office and teacher work areas.

Under-utilized former library space in Gottlieb Hall

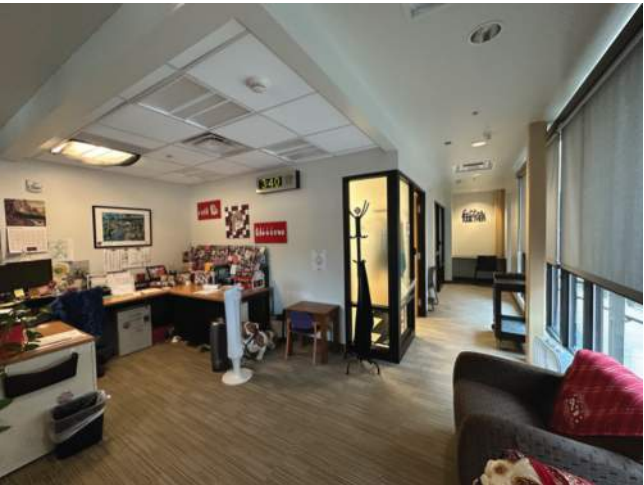
Exterior and interior glazing in Gottlieb Hall office

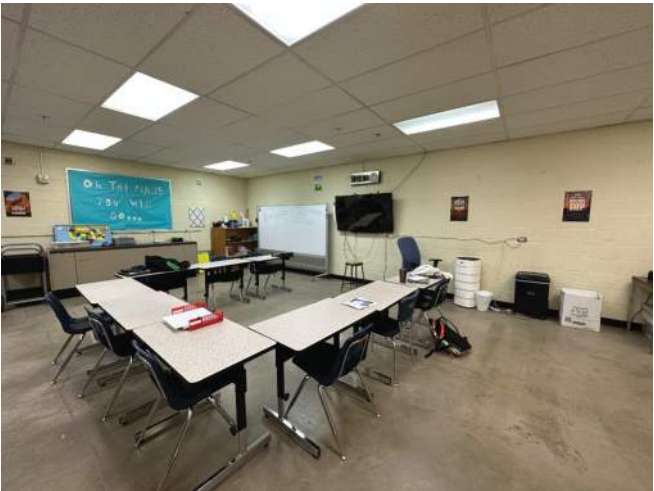
The biggest needs in Stone Hall are the lack of accessibility in restrooms, and in accessing two levels. The existing lift is unreliable, causing scheduling shifts to keep students who cannot navigate between levels on the main level. There is a desire to bring back career and technical programs, however, staffing those positions is not currently feasible due to funding and required certifications. The lack of windows in most classrooms was also discussed as a deficiency in the current spaces.

Windowless classroom in Stone Hall

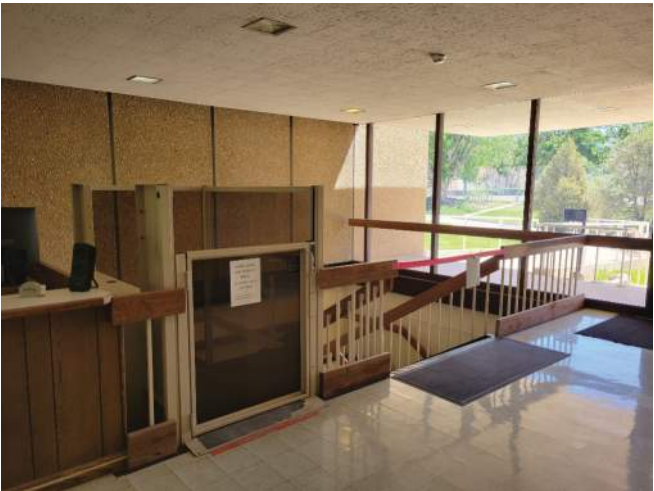
Vertical platform lift

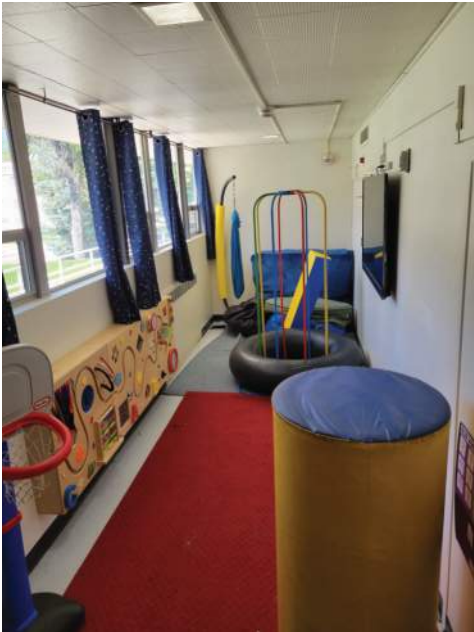
Space concerns in the preschool surround the need for additional nap and physical therapy square footage. The current sensory/PT space is in a makeshift space at the end of a corridor. Additional toileting facilities, office space, and classrooms for program expansion were also mentioned.

Sensory space in EEC

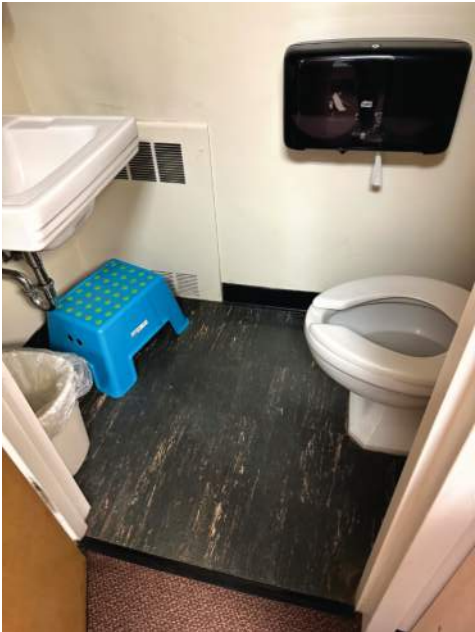
Preschool toilet room in EEC

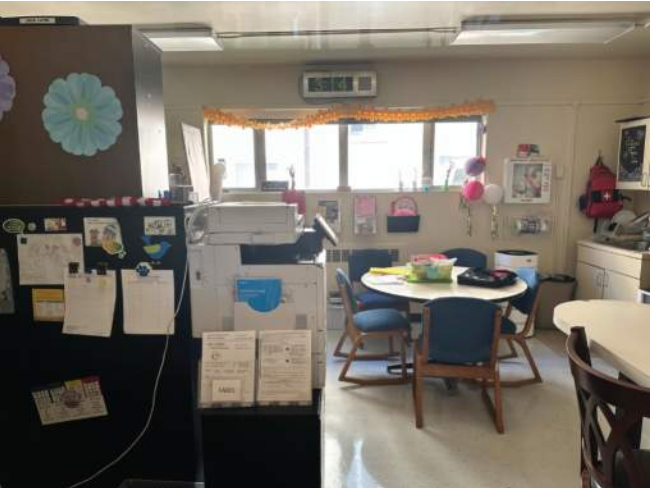
The main office in the EEC building does not have an accessible restroom, and only has space for one bed and one cot in the same room. Office space for the nurses is inadequate, as is storage for linens, medications, and files. The satellite clinics within Adams and Gottlieb are sized more reasonably for remote locations, but conditions in Adams are dismal.

Office space in Student Health

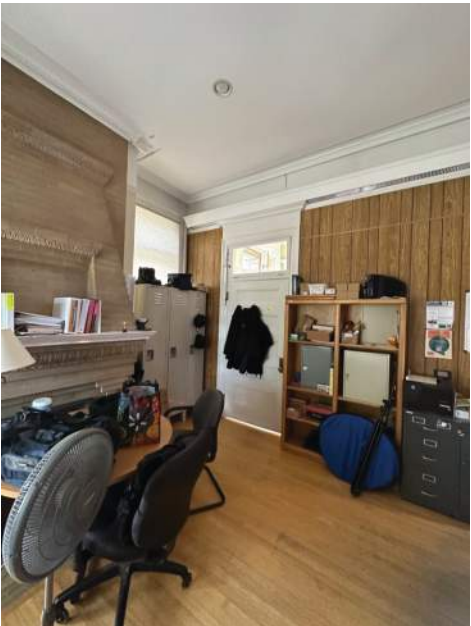
The office space in the Administration building is currently adequate, though there is concern that increased camera usage, equipment, and additional staff will increase their needs soon.

Security office in Admin Building

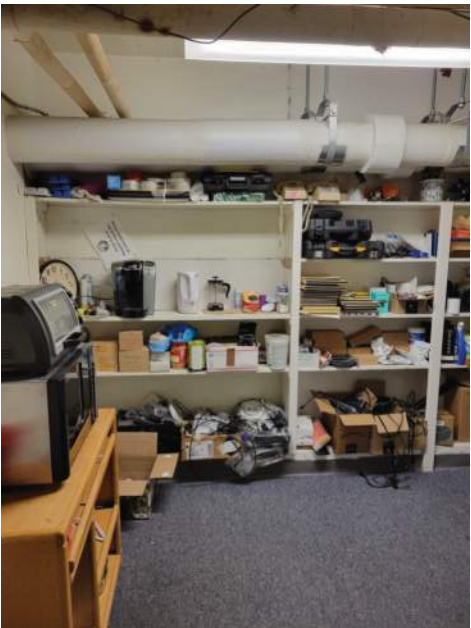
Their space in the basement of Argo Hall addresses their needs. They would like to better their server room from nearby water and steam lines.

Steam line passing through IT suite

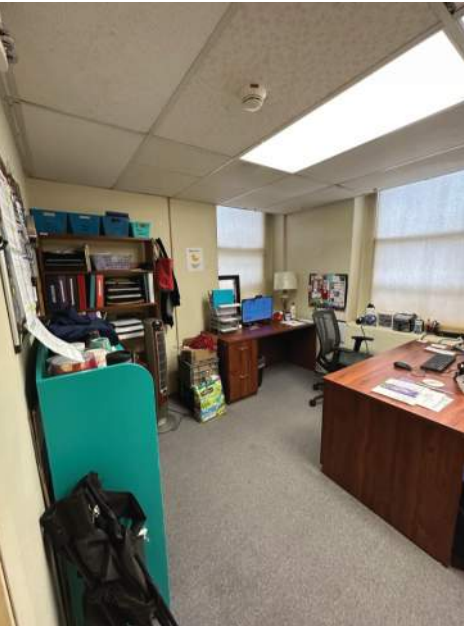
Department needs like accessible restrooms, improved thermal comfort are generally results of the facility condition of the Administration Building. Programmatic space needs are a desire to give Student Services a better space than their current basement location and a desire for better lobby security with the installation of bullet resistant films and 2-way video phones.

Basement office space

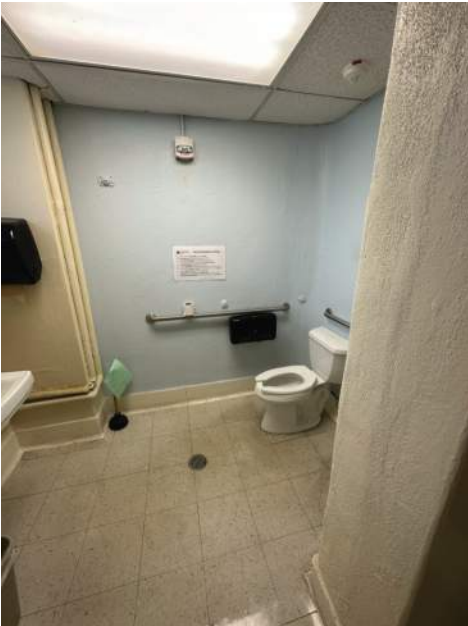
Existing Admin Building restroom

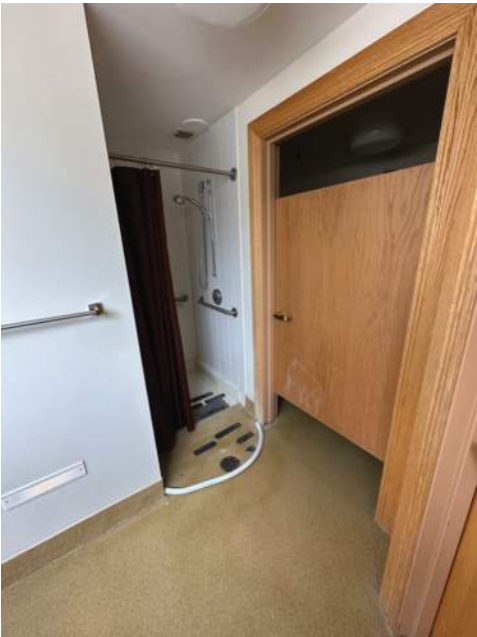
Shared bathroom in Brown Hall

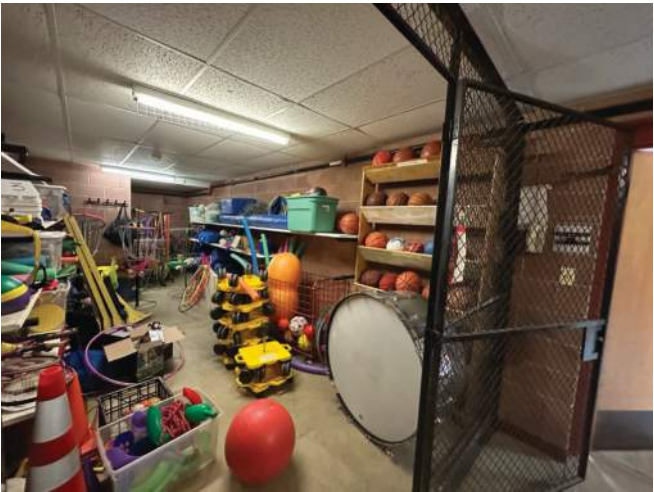
*Extracurricular Activities* – There is considerable competition for space within the gym building between athletics, activities, and physical education interests. Storage space for equipment, and competition spaces for goal ball and wrestling where equipment can be left set up without impacting educational programs are both in demand.

Gymnasium storage

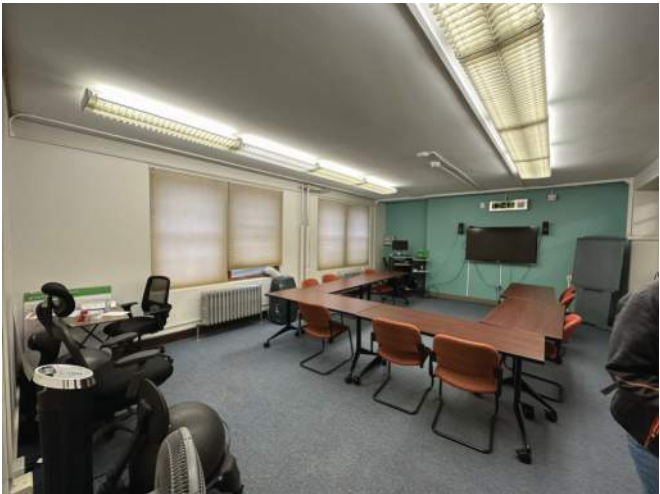
The biggest spatial need for Outreach aligns with their desire for growth. They would like to have better training spaces where they can provide in person professional development for their staff located across the state. Additionally, they plan to increase their baby and toddler programming and the connection to the preschool program. This would require additional space beyond the single classroom they currently have in West Hall.

Existing Outreach conference room in West Hall

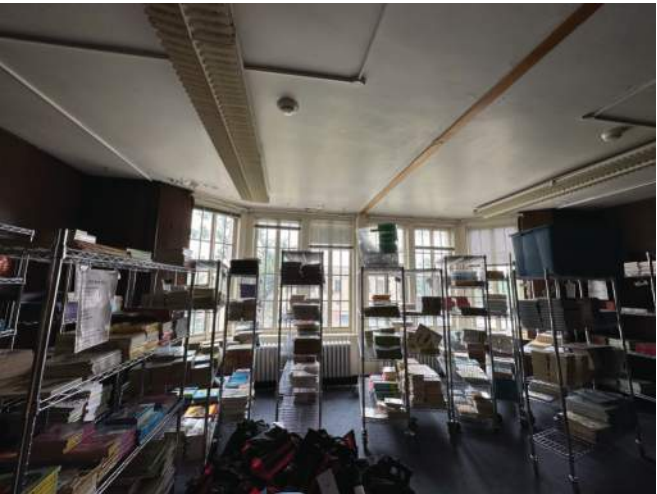
Existing Outreach storage room in West Hall

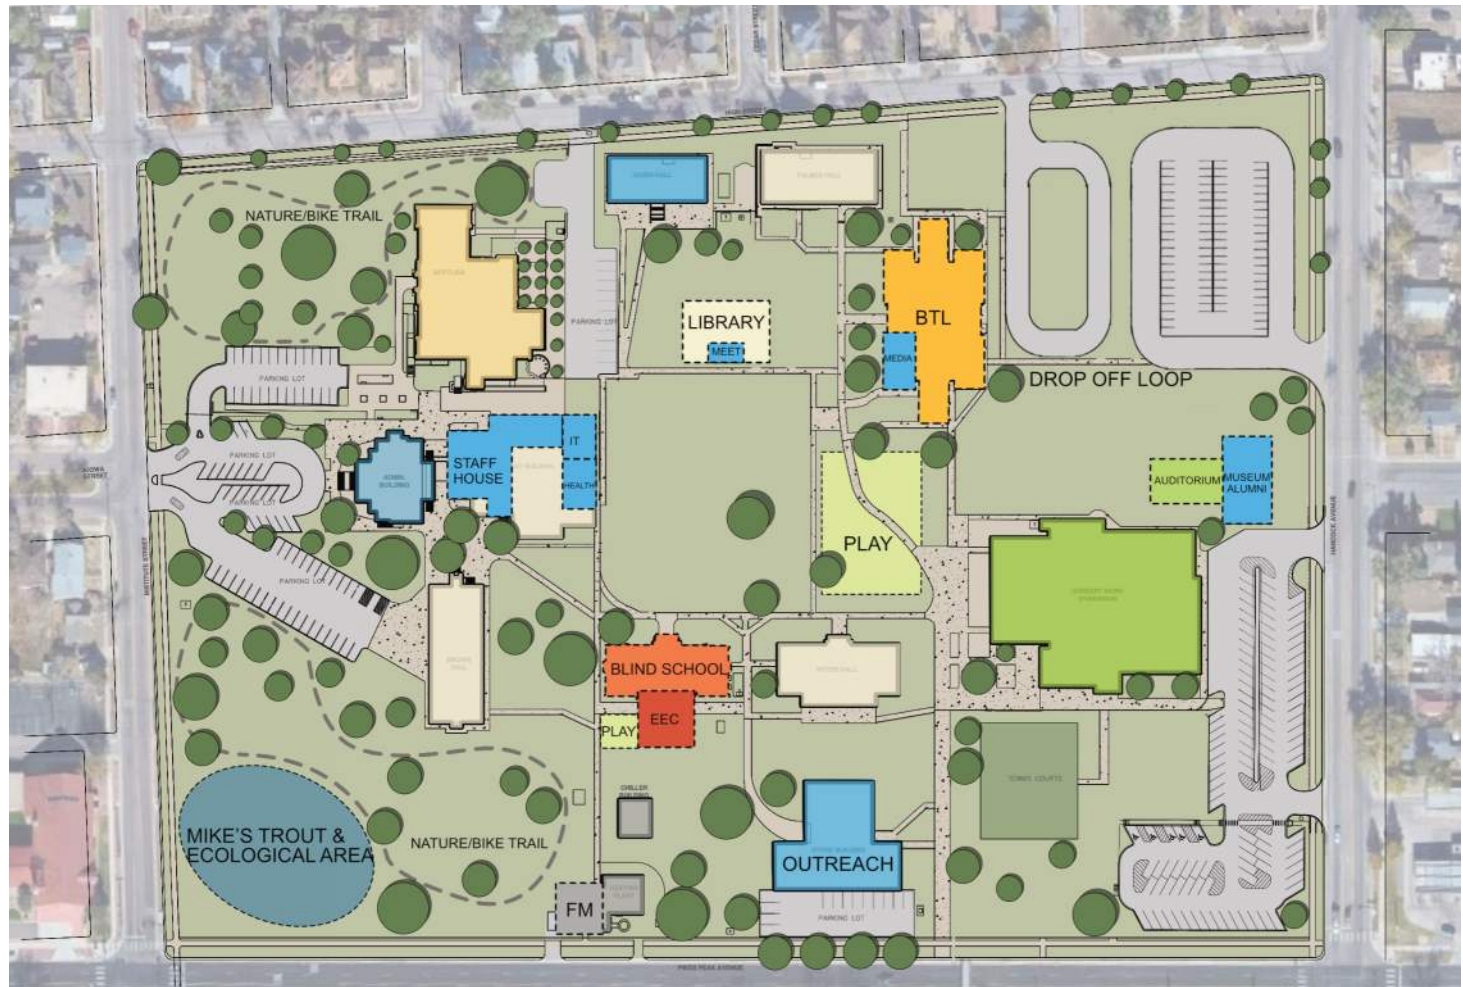
- Blind School and EEC move to renovated West Hall
  - Renovate Adams Hall for Bridges to Life
  - Add parking and revise drop off in NE corner of site
  - Demolish Lions Hall to allow for creation of new library with historically complimentary architecture as “heart” of campus
- Relocate FM offices to renovated Steam Plant and demolish Industrial Building and EEC building
  - Renovate and build addition at Barn for meeting space

Pros	Cons
Consolidated drop off location	Student Health needs to be on main level
Large parking lot added	Parking lot is far from secure entry and main staff areas and could only be used for outward-facing events
Large quad at center of campus with demolition of Industrial and EEC buildings

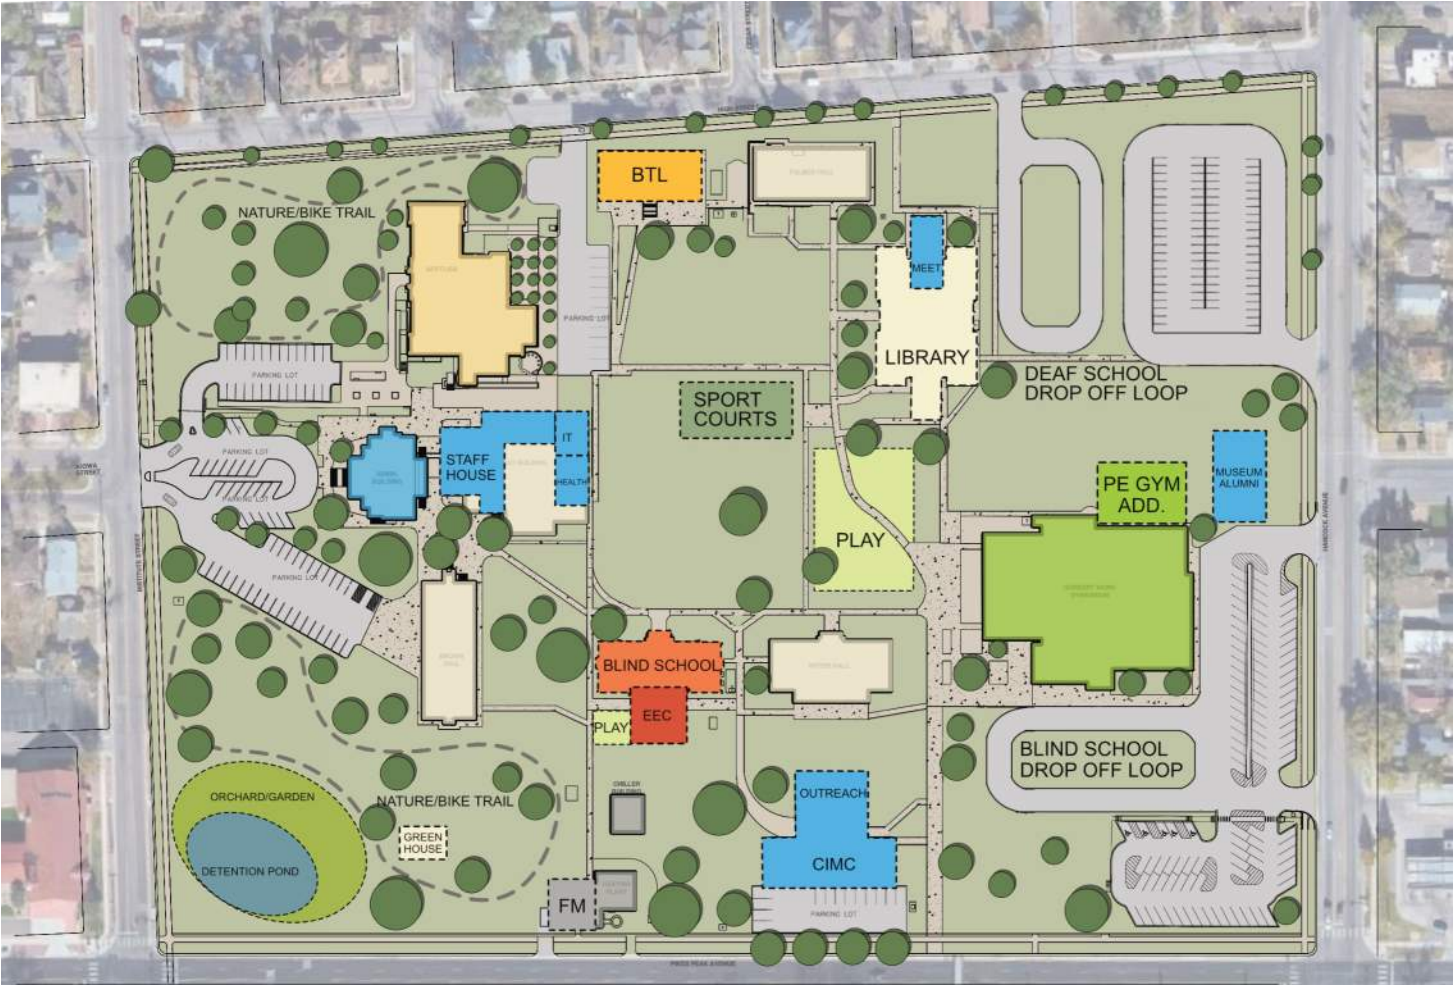
- Blind School and EEC move to renovated West Hall
  - Renovate Adams Hall for Library
  - Add parking and revise drop off in NE corner of site
  - Add drop off for Blind students in SE corner of site
  - Demolish Lions Hall
- Relocate FM offices to renovated Steam Plant; demolish Industrial Building and EEC
  - Gym addition and central sports courts in quad
  - Bridges to Life moves to Jones Hall
  - CMIC moves to Stone Hall

Pros	Cons
Better Blind drop off location for access to West Hall	Older students in Jones too close to younger students in Gottlieb
BtL/EC moves to central campus location	CIMC must move from relatively new space
Large quad at center of campus with demolition of Lions Hall, Industrial, and EEC buildings	Drop off/pick up locations are split, requiring additional staff
Gymnasium addition to lessen crowding of programs needing athletic space	Library is likely over sized for needs
CIMC gets a less central location in Stone for storage and deliveries

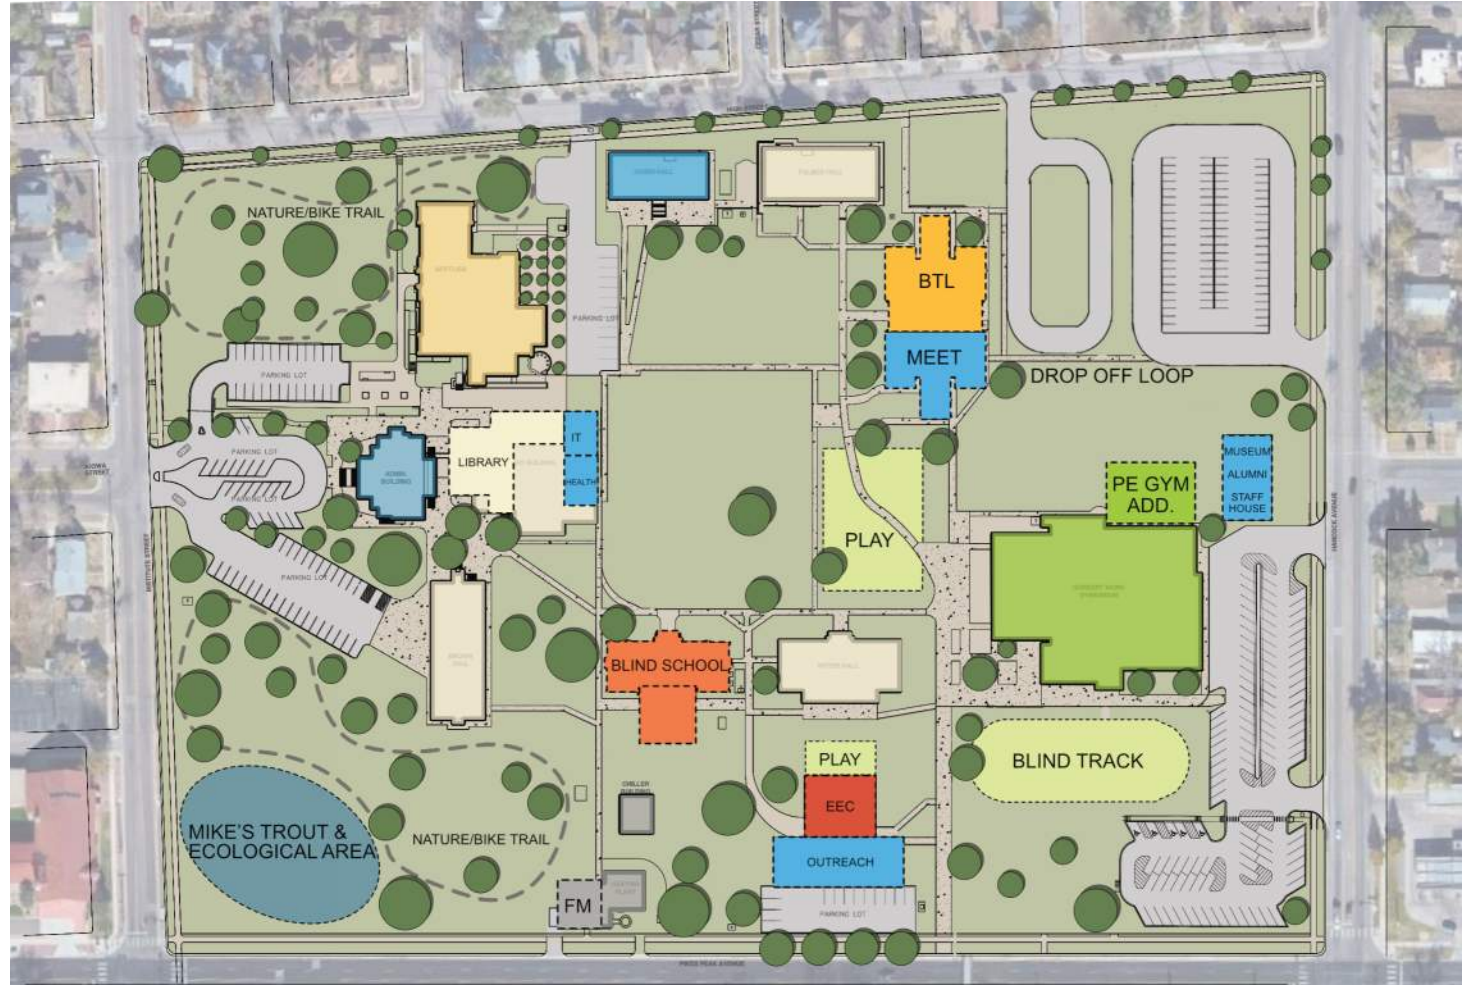
## OPTION 3:

- Blind School moves to renovated West Hall
  - Renovate Stone Hall for EEC and Outreach
  - Renovate Adams Hall for Bridges to Life
  - Add parking and revise drop off in NE corner of site
- Relocate Blind track to SE
  - Demolish Lions Hall
  - Relocate FM offices to renovated Steam Plant; demolish Industrial Building and EEC
  - Gym addition

Pros	Cons
Consolidated drop off location	Funding requests have already been submitted for West Hall to house both the Blind School and EEC
Blind track is kept on main campus	Larger meeting center reduces BtL capacity
More space for Blind School and EEC	
Better proximity between EEC and Little Language Learners	
Better pick up/drop off access for EEC parents

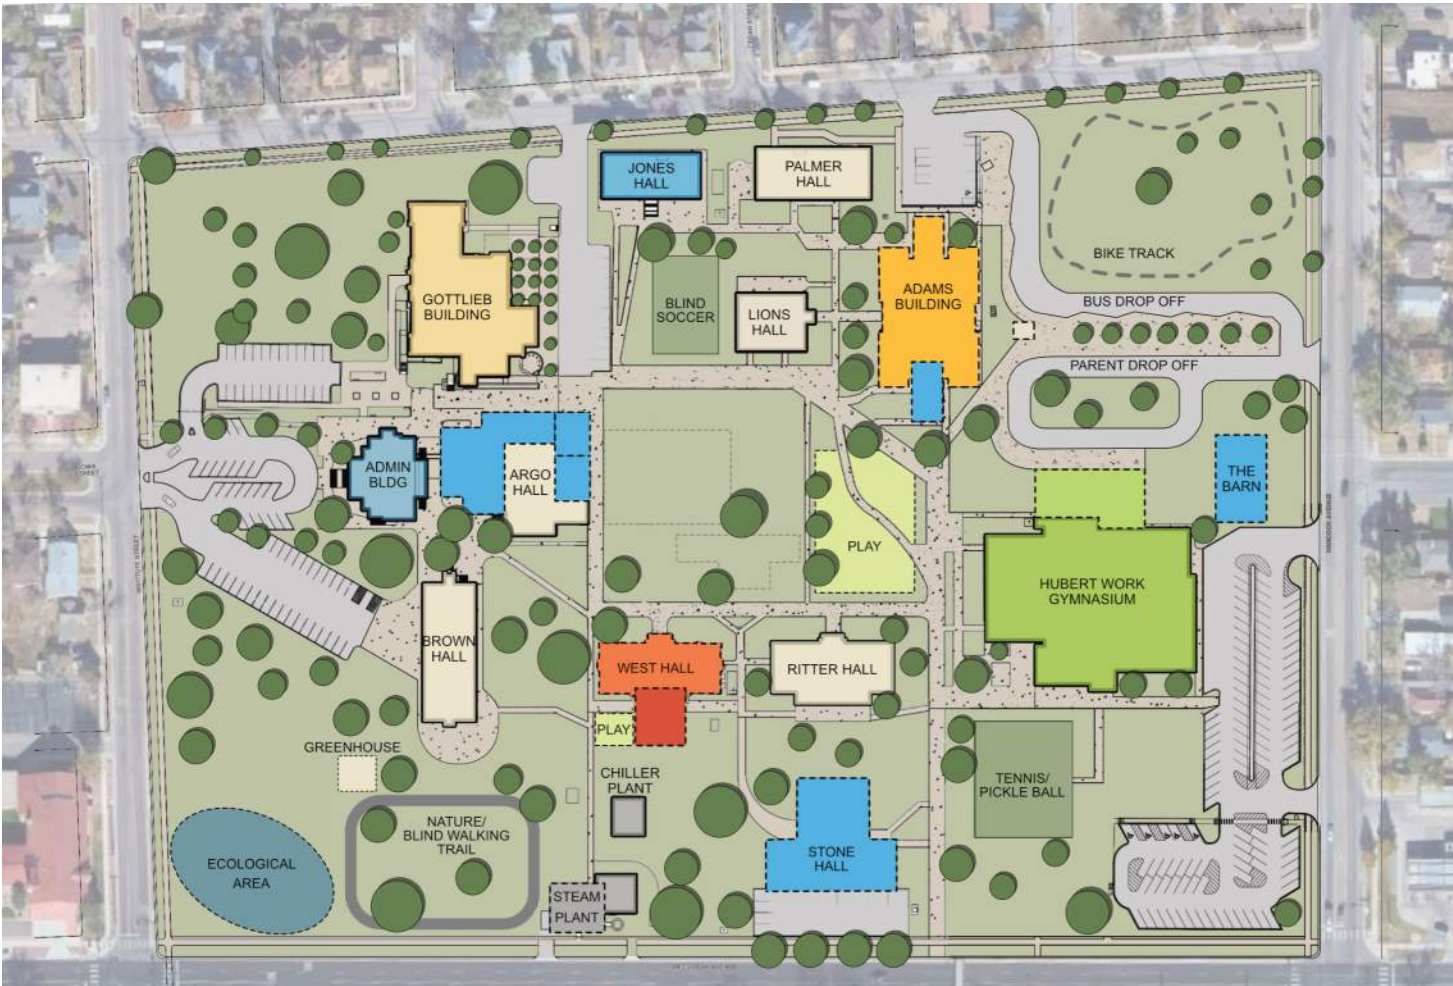
- Revise drop off in NE corner of site
- Blind soccer field added near Lions Hall on central campus

Pros	Cons
Consolidated drop off location	Soccer field location limits opportunity to rent out as a source of revenue
Keeping Industrial Building is not desired	As drawn, there is no additional parking for events
Large quad at center of campus with demolition of Industrial and EEC buildings	
Blind soccer field is centrally located for student use	
Drop off location is near both gym and playground for before and after play/gathering

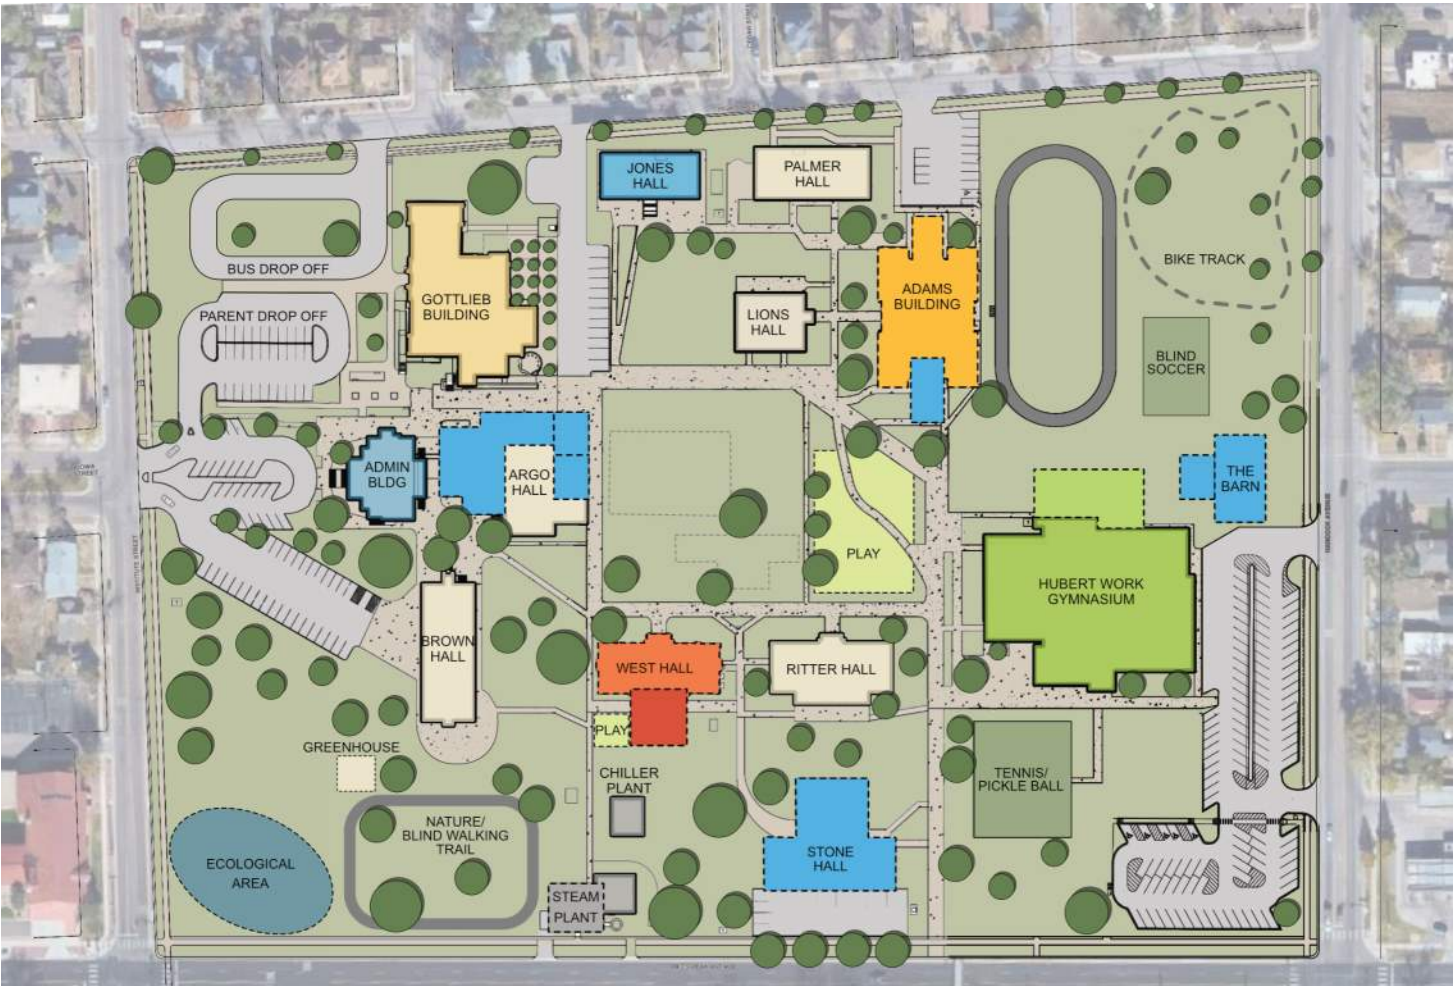
- Add consolidated student drop off and parking in NW corner of site
- Blind soccer field added in NE corner of site

Pros	Cons
Consolidated drop off location	Places extensive paving at front, public face of the school
Provides additional parking in area closest to visitor check in/security	Bus lane is shorter than what their current needs are for queuing
Large quad at center of campus with demolition of Industrial, and EEC buildings	
Keeps the existing location of the Blind track and adds adjacent soccer field

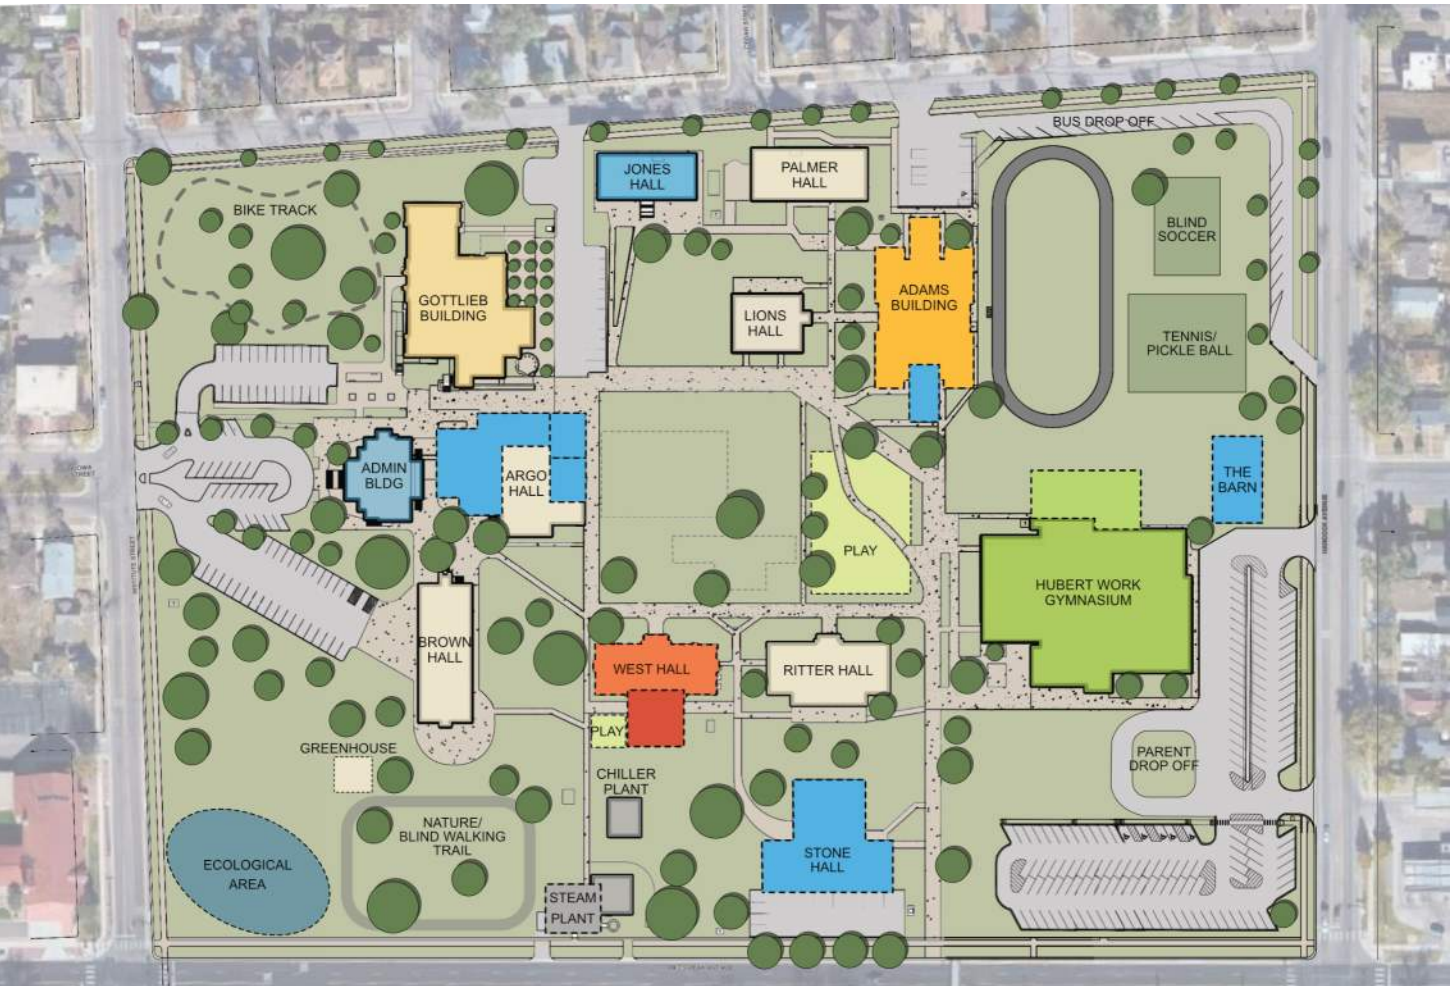
## PLAN OPTION A - DROP OFF OPTION 3:

- Add Blind student drop off and parking in SE corner of site
- Blind soccer field added in NE corner of site
- Relocate pickle ball to NE corner

Pros	Cons
Drop off location for Blind School gives better proximity to West Hall than other options	Split drop off locations require additional staffing
Blind track is kept on main campus	Soccer field location limits opportunity to rent out as a source of revenue
Student recreational facilities are consolidated to one location on main campus - track, soccer, tennis/pickle ball	Additional parking is far from secure entry in Admin
Additional parking for events
