Colorado School
for the Deaf and the Blind

TEN-YEAR FACILITY MASTER PLAN REPORT

#823291-01 | 04.23.2024

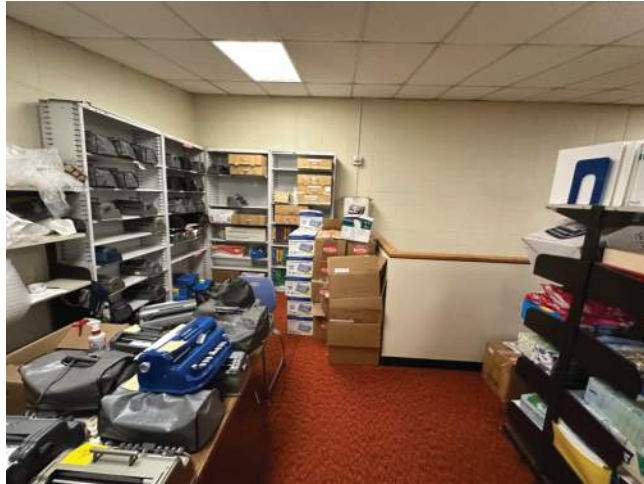
Storage conditions in Adams Hall

The most pressing spatial needs for the Blind school relate to storage. The equipment that is required by VI students is substantially larger than that for mainstream students. The classrooms in Adams do not have adequate space for the readers and Braille books needed. Additionally, the numbers of students with additional disabilities are continually increasing, requiring more space for walkers, wheelchairs, standers, and additional paraprofessionals in the classrooms to support these students. Other needs mentioned frequently are accessible restrooms, more sinks for hand washing, better acoustics, and lighting.

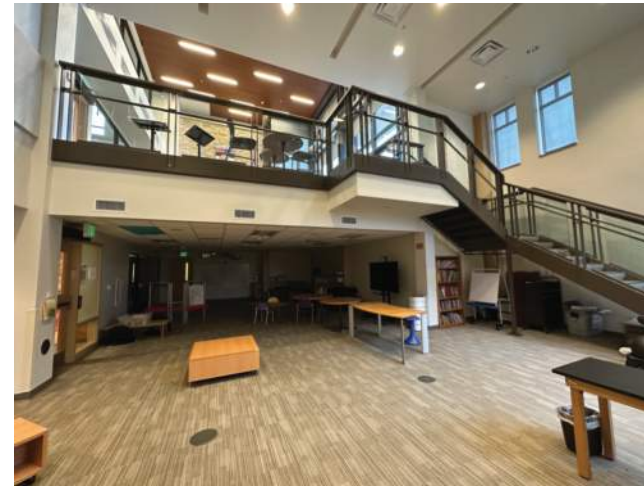
Under-utilized former library space in Gottlieb Hall

Spatial needs in Gottlieb are centered around inefficient use of spaces, lack of office space, and security concerns. With the relocation of the library to Lions Hall, the two-level Media Center is under utilized and difficult to use effectively. Additional office space is needed for the number of specialists, including psychologists, speech pathologists, and counselors. The security concerns are due to the extent of glass at the main office and teacher work areas.

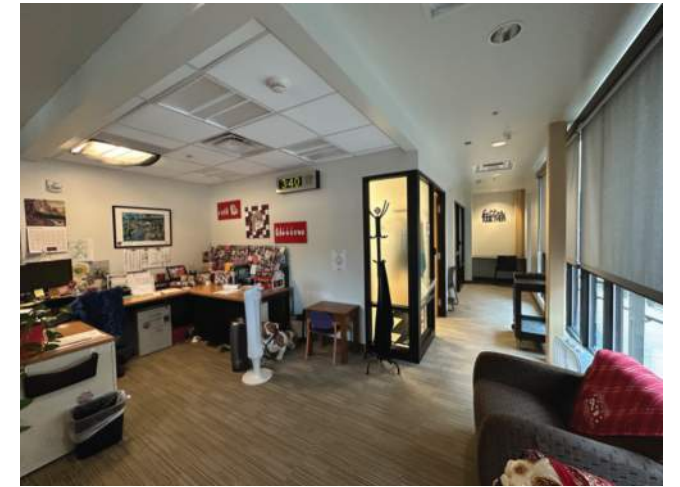
Exterior and interior glazing in Gottlieb Hall office

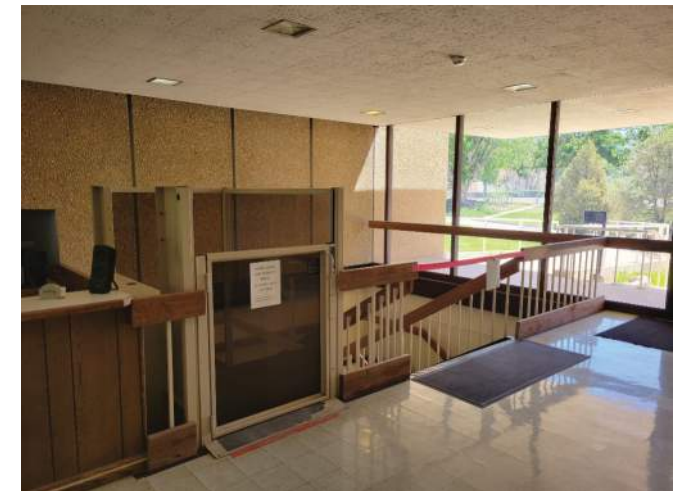
Vertical platform lift

The biggest needs in Stone Hall are the lack of accessibility in restrooms, and in accessing two levels. The existing lift is unreliable, causing scheduling shifts to keep students who cannot navigate between levels on the main level. There is a desire to bring back career and technical programs, however, staffing those positions is not currently feasible due to funding and required certifications. The lack of windows in most classrooms was also discussed as a deficiency in the current spaces.

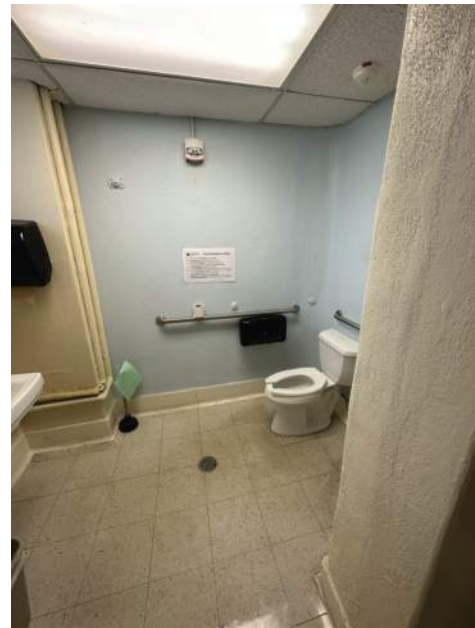
Existing Admin Building restroom

Department needs like accessible restrooms, improved thermal comfort are generally results of the facility condition of the Administration Building. Programmatic space needs are a desire to give Student Services a better space than their current basement location and a desire for better lobby security with the installation of bullet resistant films and 2-way video phones.

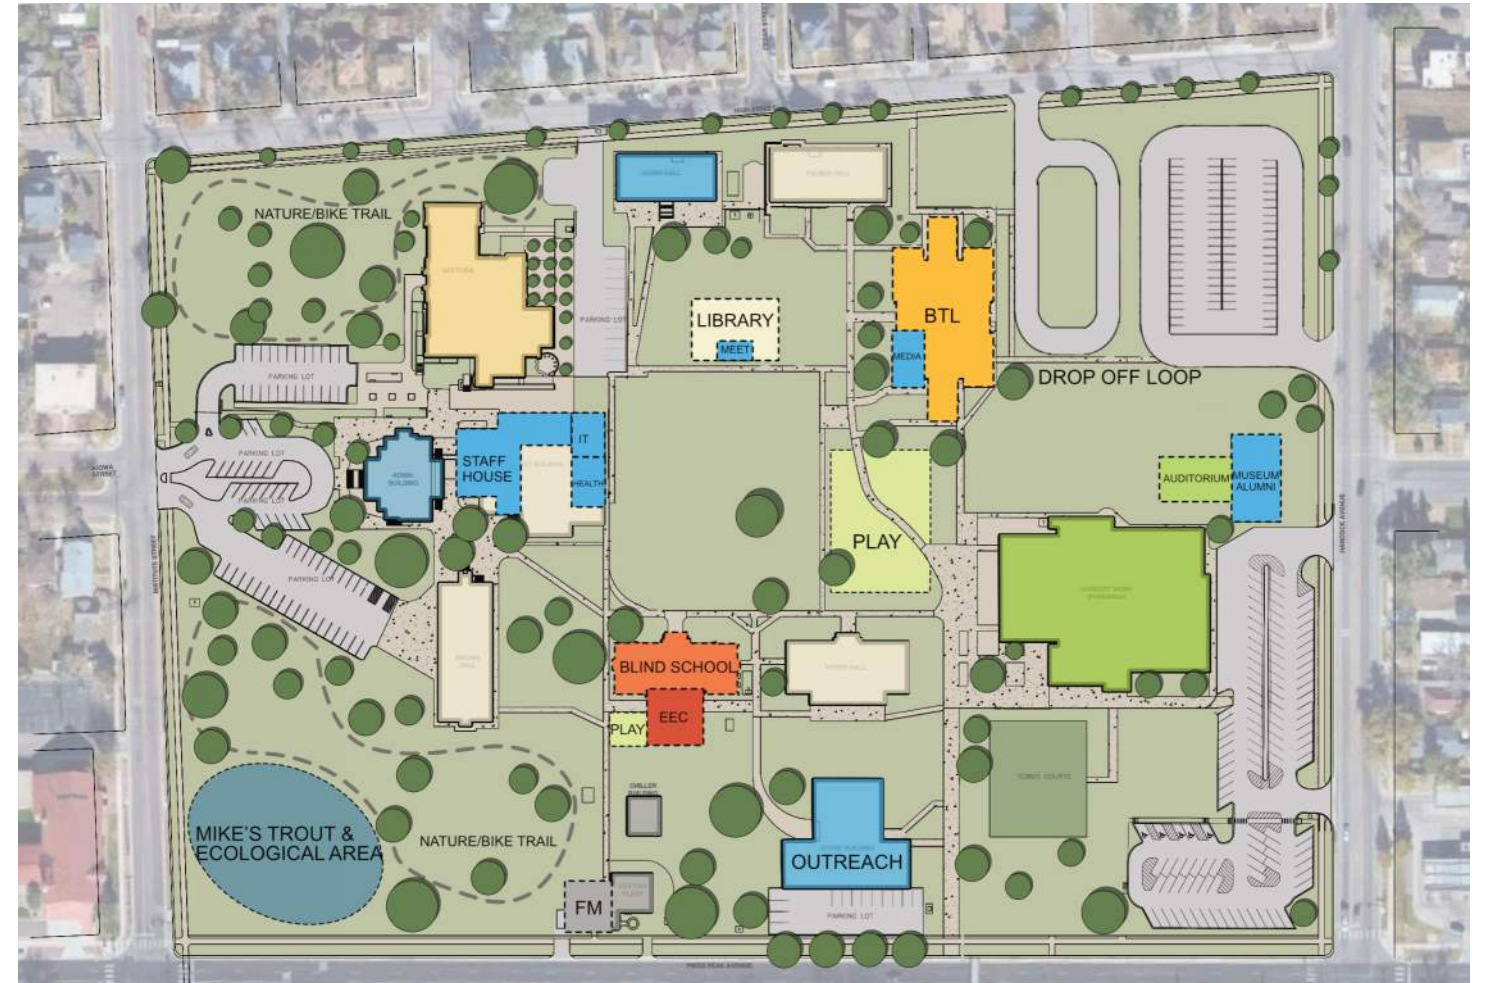
- Blind School and EEC move to renovated West Hall
- Renovate Adams Hall for Bridges to Life
- Add parking and revise drop off in NE corner of site
- Demolish Lions Hall to allow for creation of new library with historically complimentary architecture as “heart” of campus
- Relocate FM offices to renovated Steam Plant and demolish Industrial Building and EEC building
- Renovate and build addition at Barn for meeting space

Pros	Cons
Consolidated drop off location	Student Health needs to be on main level
Large parking lot added	Parking lot is far from secure entry and main staff areas and could only be used for outward-facing events
Large quad at center of campus with demolition of Industrial and EEC buildings

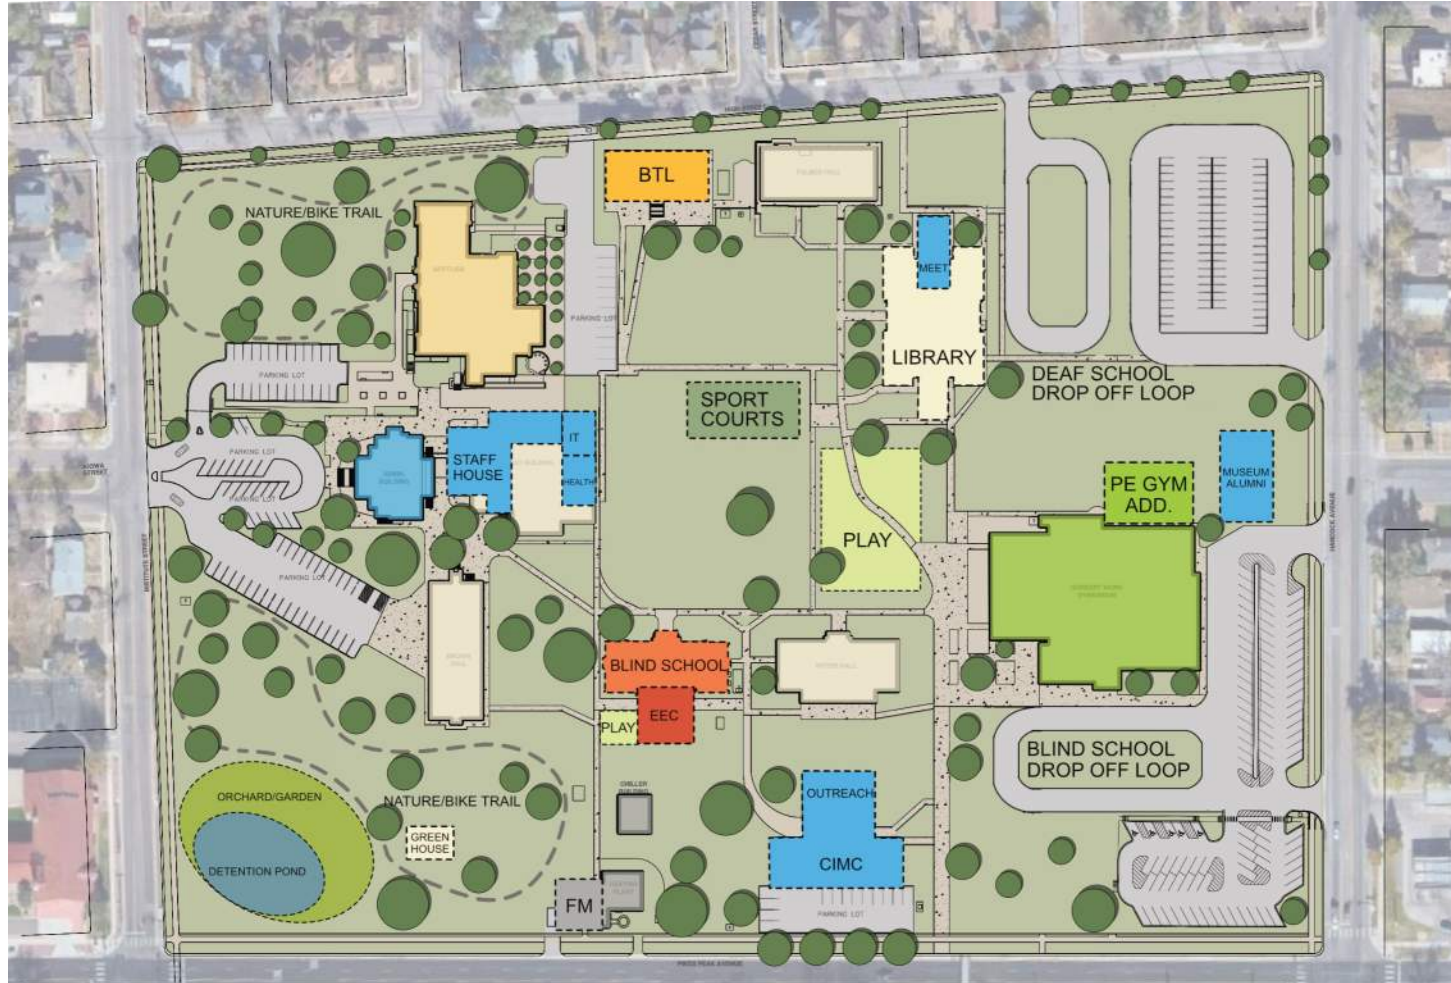
- Blind School and EEC move to renovated West Hall
- Renovate Adams Hall for Library
- Add parking and revise drop off in NE corner of site
- Add drop off for Blind students in SE corner of site
- Demolish Lions Hall
- Relocate FM offices to renovated Steam Plant; demolish Industrial Building and EEC
- Gym addition and central sports courts in quad
- Bridges to Life moves to Jones Hall
- CMIC moves to Stone Hall

Pros	Cons
Better Blind drop off location for access to West Hall	Older students in Jones too close to younger students in Gottlieb
BtL/EC moves to central campus location	CIMC must move from relatively new space
Large quad at center of campus with demolition of Lions Hall, Industrial, and EEC buildings	Drop off/pick up locations are split, requiring additional staff
Gymnasium addition to lessen crowding of programs needing athletic space	Library is likely over sized for needs
CIMC gets a less central location in Stone for storage and deliveries

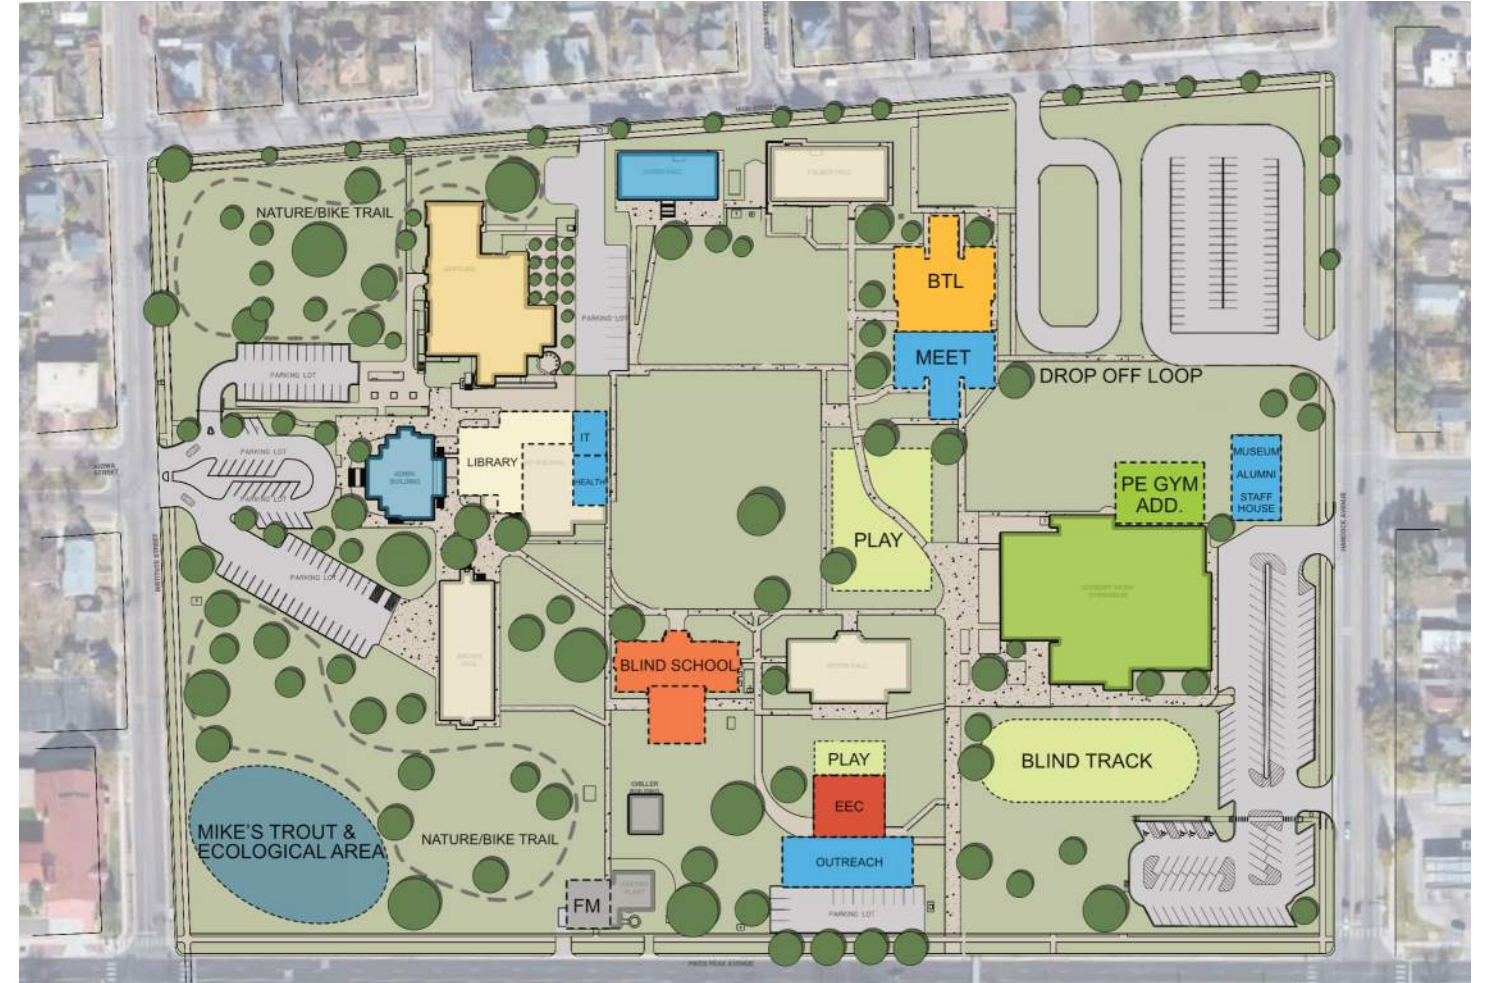
OPTION 3:

- Blind School moves to renovated West Hall
- Renovate Stone Hall for EEC and Outreach
- Renovate Adams Hall for Bridges to Life
- Add parking and revise drop off in NE corner of site
- Relocate Blind track to SE
- Demolish Lions Hall
- Relocate FM offices to renovated Steam Plant; demolish Industrial Building and EEC
- Gym addition

Pros	Cons
Consolidated drop off location	Funding requests have already been submitted for West Hall to house both the Blind School and EEC
Blind track is kept on main campus	Larger meeting center reduces BtL capacity
More space for Blind School and EEC	
Better proximity between EEC and Little Language Learners	
Better pick up/drop off access for EEC parents

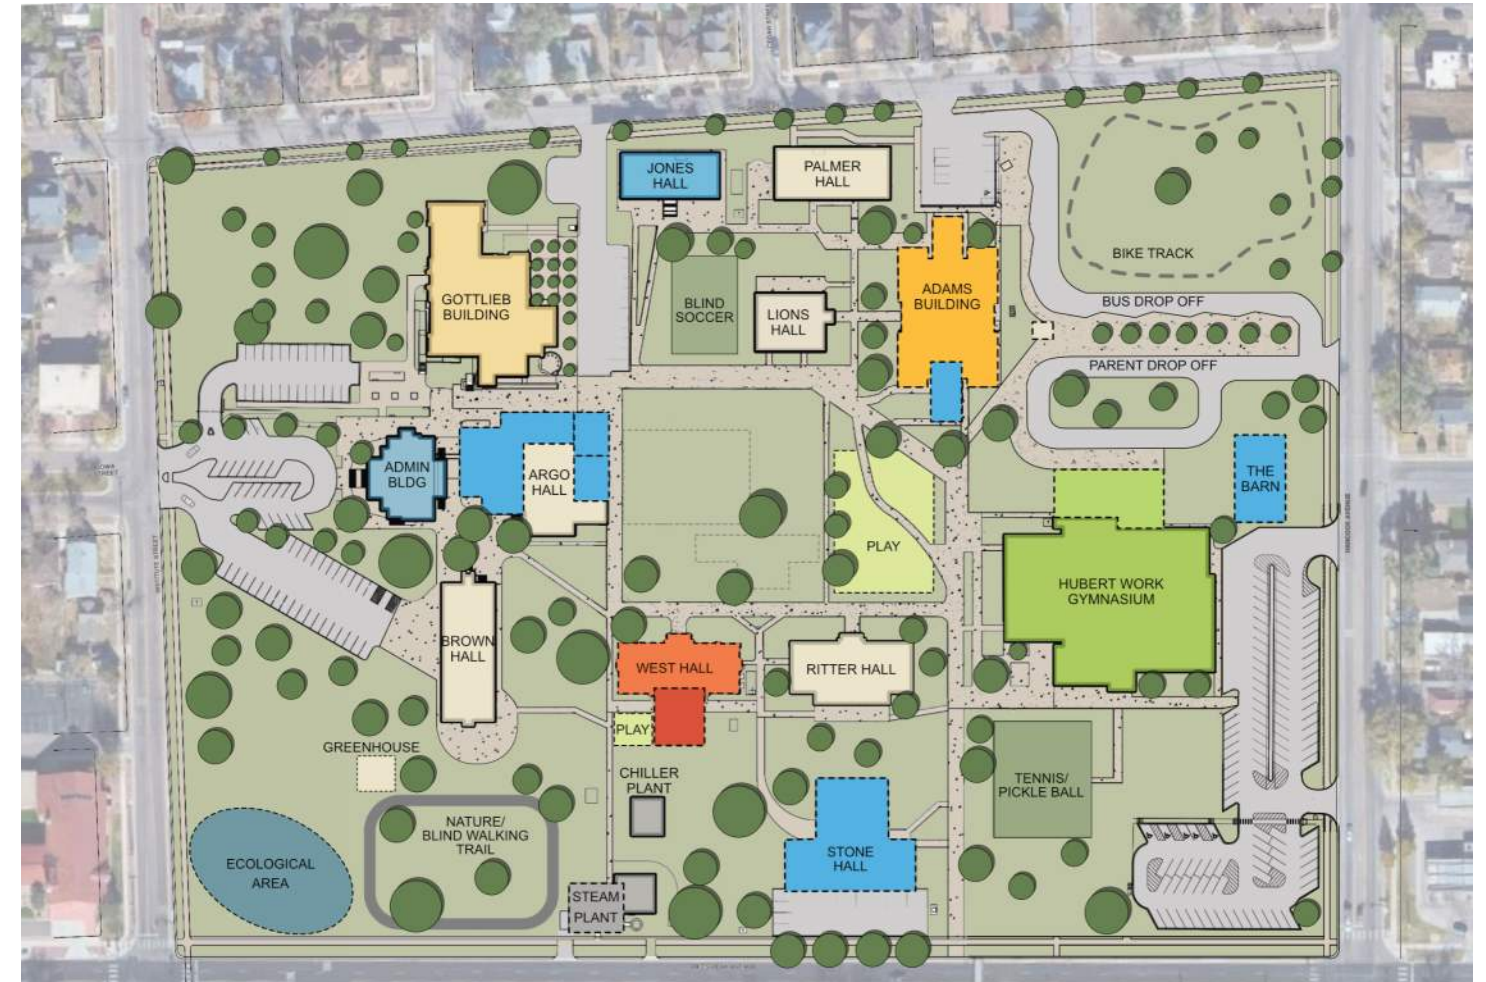
- Revise drop off in NE corner of site
- Blind soccer field added near Lions Hall on central campus

Pros	Cons
Consolidated drop off location	Soccer field location limits opportunity to rent out as a source of revenue
Keeping Industrial Building is not desired	As drawn, there is no additional parking for events
Large quad at center of campus with demolition of Industrial and EEC buildings	
Blind soccer field is centrally located for student use	
Drop off location is near both gym and playground for before and after play/gathering

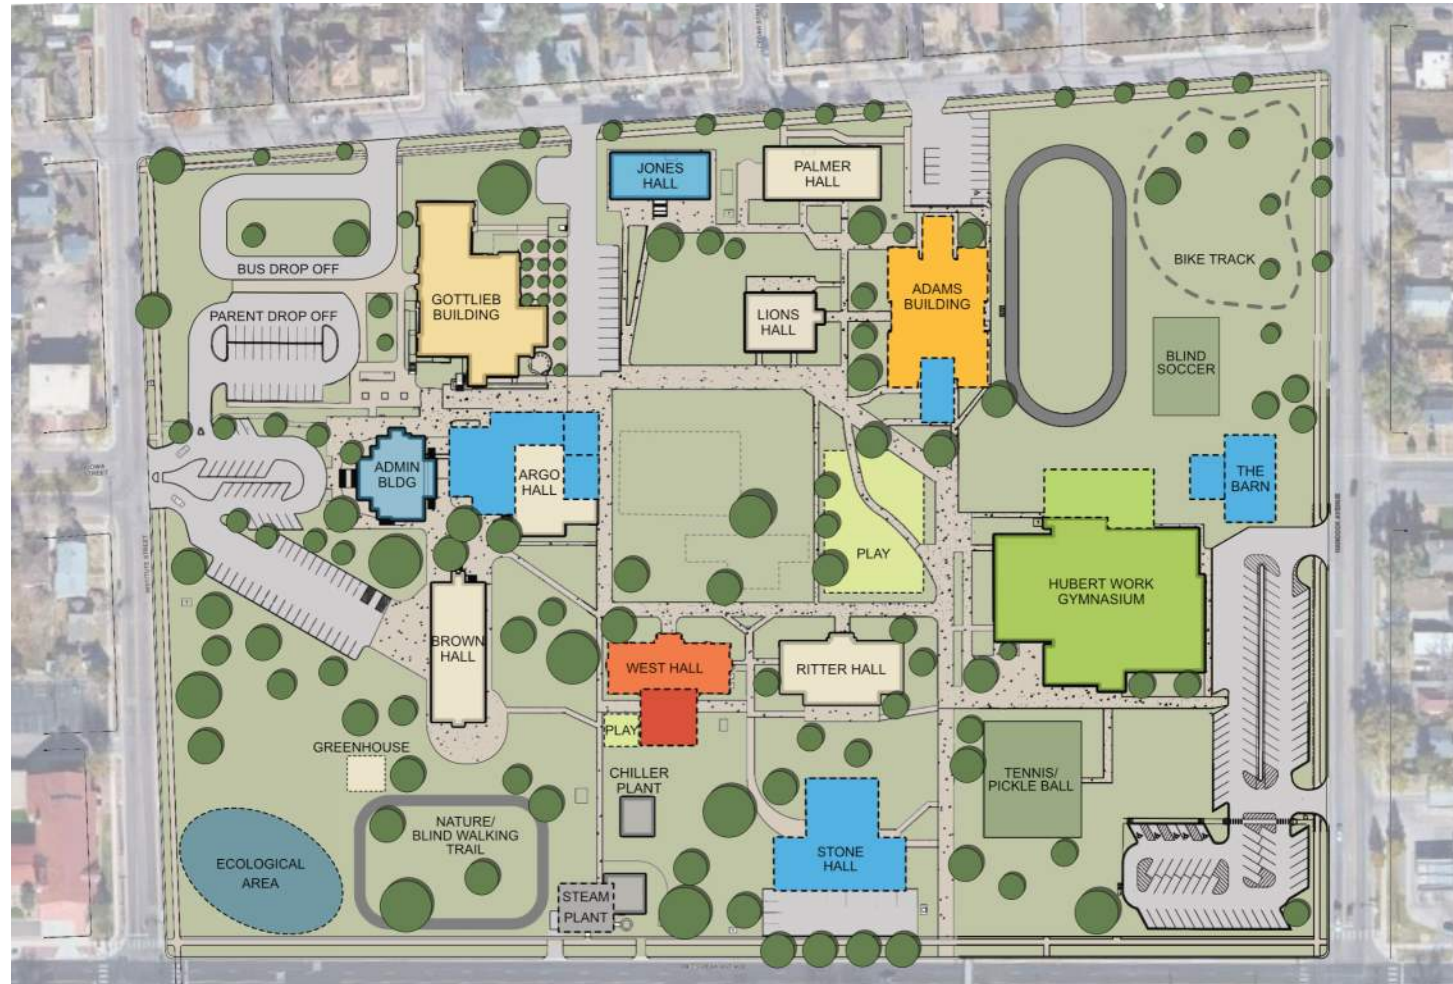
- Add consolidated student drop off and parking in NW corner of site
- Blind soccer field added in NE corner of site

Pros	Cons
Consolidated drop off location	Places extensive paving at front, public face of the school
Provides additional parking in area closest to visitor check in/security	Bus lane is shorter than what their current needs are for queuing
Large quad at center of campus with demolition of Industrial, and EEC buildings	
Keeps the existing location of the Blind track and adds adjacent soccer field

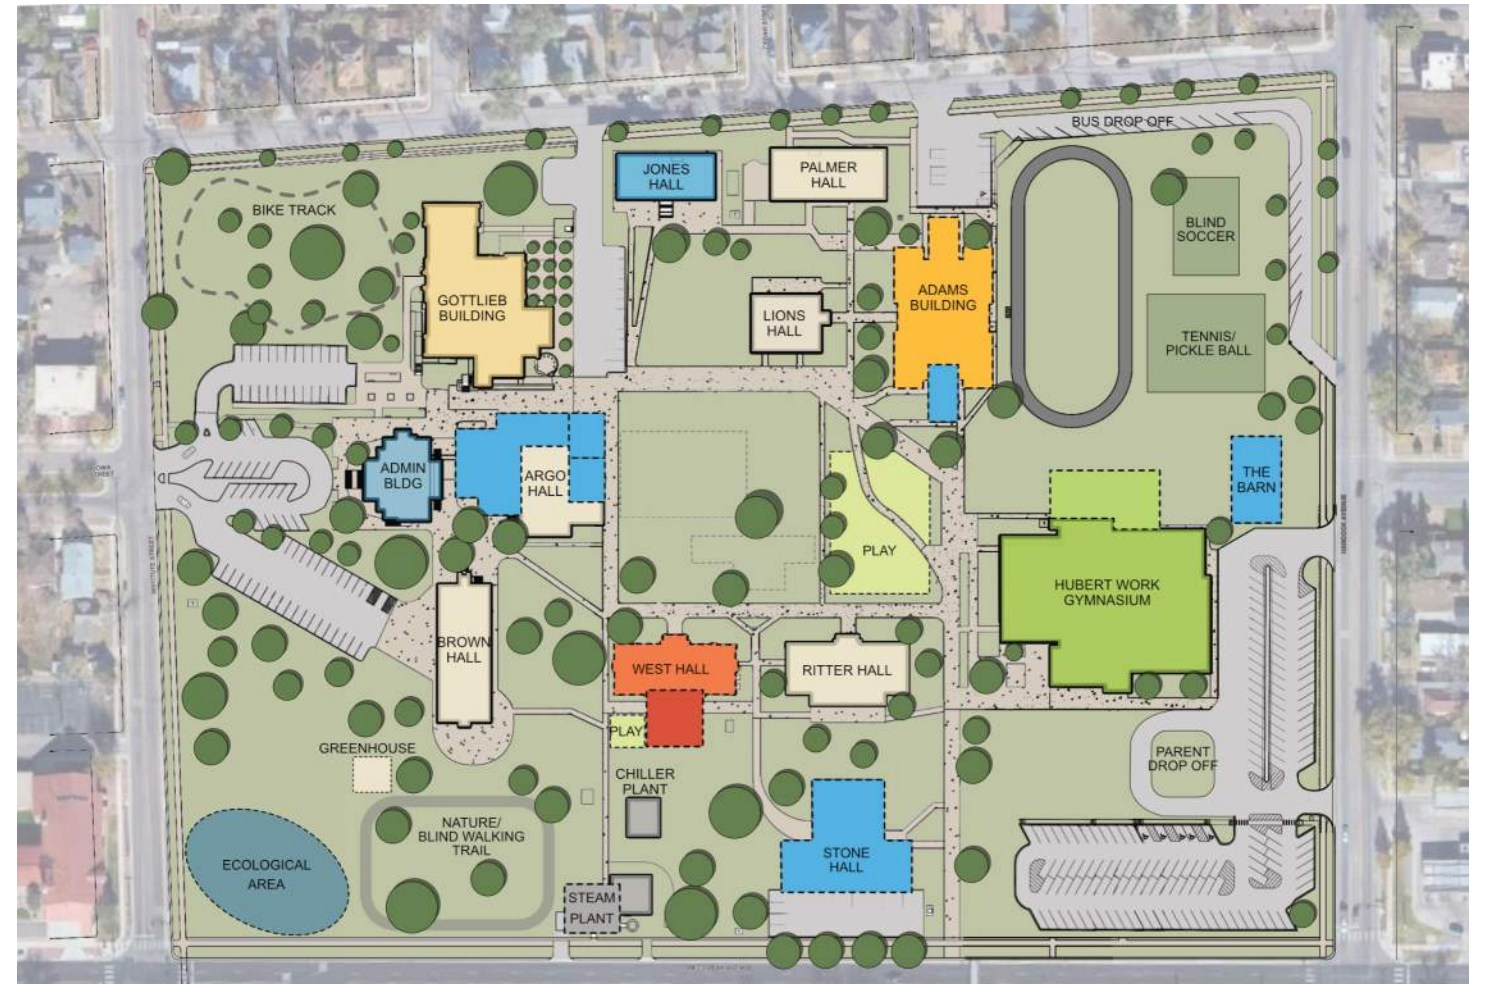
PLAN OPTION A - DROP OFF OPTION 3:

- Add Blind student drop off and parking in SE corner of site
- Blind soccer field added in NE corner of site
- Relocate pickle ball to NE corner

Pros	Cons
Drop off location for Blind School gives better proximity to West Hall than other options	Split drop off locations require additional staffing
Blind track is kept on main campus	Soccer field location limits opportunity to rent out as a source of revenue
Student recreational facilities are consolidated to one location on main campus - track, soccer, tennis/pickle ball	Additional parking is far from secure entry in Admin
Additional parking for events
